# Manhole Inspection Summary

Manhole # S17GG1001MH

**Location** Address: **SPRUCE DR**

Cross Street: **OSWEGO AVE**

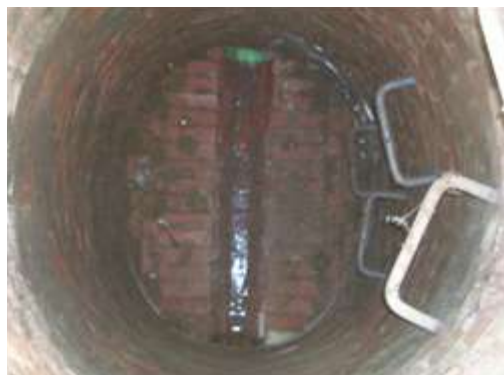
Top View

Evidence of surcharge - Bench debris.  
Corroded steps.

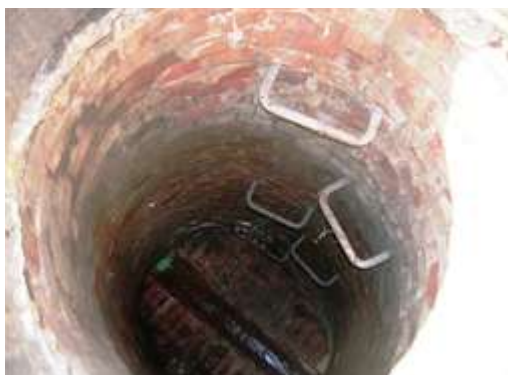
Defect

Frame leaks. Adjustment and Corbel  
deterioration and infiltration. Barrel  
infiltration - other side.

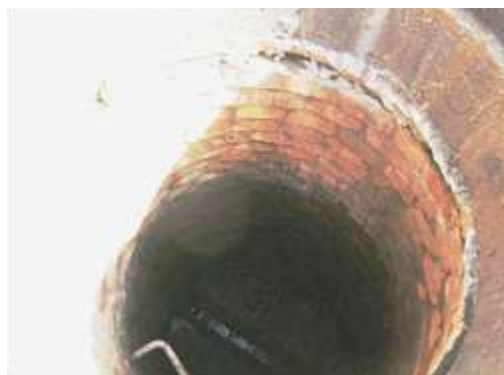
Defect

Frame leaks. Adjustment and Corbel  
deterioration and infiltration. Barrel  
infiltration.

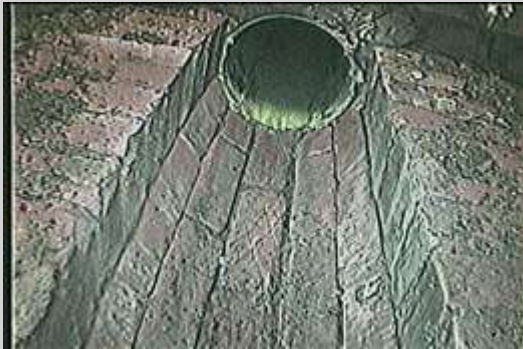
### 8 in. Circular Gravity Sewer Pipe Out @ 12 O'Clock

Channel deterioration.

Infiltration: **Evidence** Pipe Seal Cond: **Cracked**

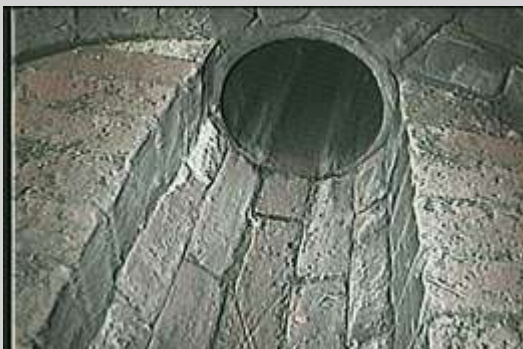
### 8 in. Circular Gravity Sewer Pipe In @ 6 O'Clock

Barrel deterioration and infiltration.

Infiltration: **Evidence** Pipe Seal Cond: **Unknown**
